Fastener Corrosion in Treated Lumber

by Laurence Claus

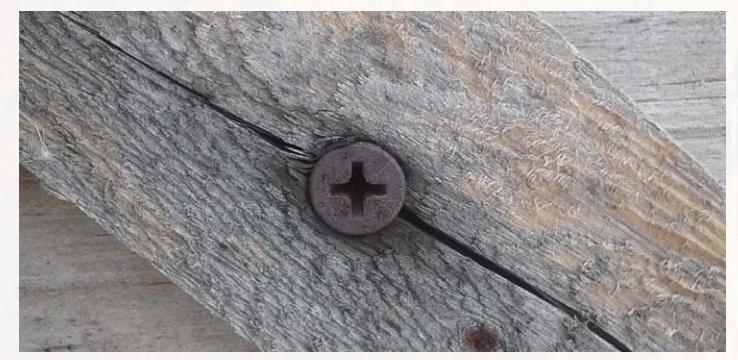
Figure 1: Zinc Plated Fastener Example in Alternate Treated Lumber After Several Years Exposure 图1、镀锌紧固件曝露于经处理后替代性木材数年后的实例

One of the unexpected consequences of the alternate wood preservatives was their increased corrosivity to fasteners, anchors, and metal connectors. In fact, many of 紧固件产品,无论是钉子、螺丝、锚或是金属连接器,在木质/ 木材结构都扮演关键性重要的角色。从本质上说,这些产品的关键 性在于材料的接合、承担或辅助分散结构荷载。在许多应用案例, 这些紧固件安装在腐蚀性环境,或与腐蚀性物质接触。这种情形 常见例子包括:暴露在经常潮湿或含水气的环境、处于沿海地带或 是饱含盐份的大气中、经过防腐处理的木材,或与性质相异金属接 触。这些因素任何一种或其中几种的组合都可能腐蚀不符规格的紧 固件,使紧固件、周围木材或两者造成接合荷载功能丧失。因此,采 购人在规格上对于紧固件应用环境必须具有相当的认识,并且谨慎 选择紧固件的涂装或基材原料,使这些风险降到最低。

these new alternatives have proven to be two to three times more corrosive than CCA preserved wood. Even though this does not eliminate the possibility of using metal fasteners in these materials, it does mean that the choice of specifying the right fastener has become more complex, challenging, and critical.

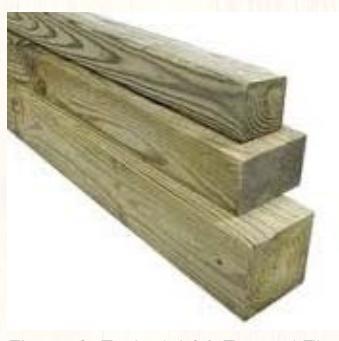
Figure 2: Typical ACQ Treated Timber 图2、典型的铜烷基铵 ACQ 防腐木材

CCA has been replaced by a variety of different treatments. In the United States the most common alternate treatments are Alkaline Copper Quaternary (ACQ), Copper Azole (CBA and CA), Sodium Borate (SBX), and Micronized Copper Quaternary (MCQ). ACQ is a combination of about 2/3rd copper oxide and 1/3 guaternary ammonium compound. Like CCA, there are several different standards that exist for ACQ, Types B, C, and D. ACQ-B is the most prevalent treatment in the United States because of its improved ability to penetrate certain western species of US pines. CA-B or copper azole type B is used in the United States and is a waterborne solution of 96% copper and 4% tebuconazole. SBX or borate treatments are generally reserved for timbers being treated for termite or other insect infestation hazards. Most borate treatments use disodium octaborate tetrahydrate because of its excellent water solubility which facilitates the application of more concentrated solutions. Their lack of copper constituents generally makes them unsuitable for prolonged wet conditions and so they are usually used in "dry" applications. Finally, MCQ utilizes micro-sized particles of solid copper rather than aqueous copper like its close cousin, ACQ.

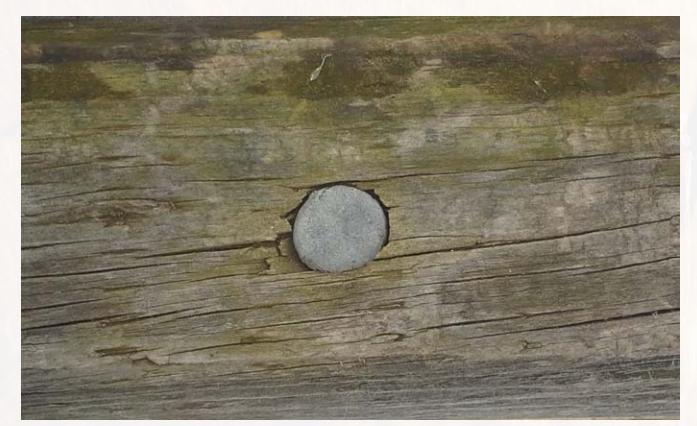
Figure 3: Hot Dipped Galvanized Fastener Example in Treated Landscape Timber after Several Years Exposure 图3、热镀锌紧固件曝露于处理的景观木材数年后的实例

Hot dip galvanized fasteners can exhibit different rates and subsequent levels of corrosion based in the thickness of the zinc layer. As a result, Simpson Strong-Tie recommends a thicker version of hot dipped galvanized metal connector when exposed to certain environments or contacting the alternate treated wood addressed in these studies. In addition to hot dipped galvanized fasteners they also recommend austenitic stainless steel, but caution that best practice dictates not mixing dissimilar materials. In other words, if using hot dip galvanized connectors, the fasteners should also be hot dip galvanized and stainless connectors should use stainless fasteners.

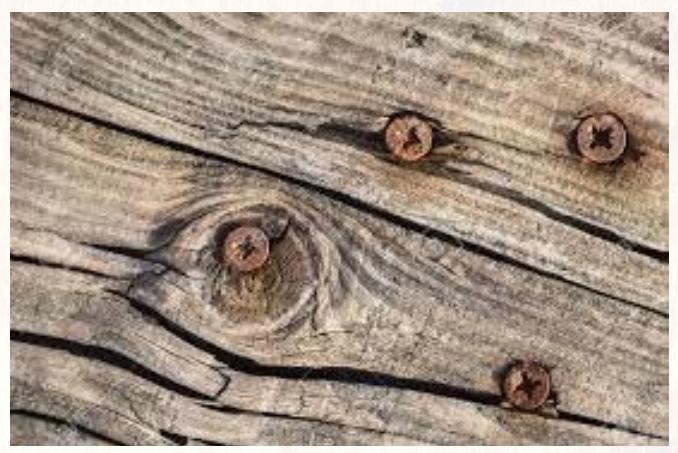
Figure 4: Example of "Nail Sickness" 图4、钉子疾病的例子

"Deterioration of metallic fasteners not only weakens the fastener itself, but the chemical reactions involved in corrosion can also weaken the timber surrounding the fastener." They refer to this as "Nail Sickness" and, as a result, suggest that the fastener and timber be considered as a system to minimize any risks in structural safety or longevity.
